Apr 16th, 2026

123 Anywhere St, Wasilla, AK 99654

Home Inspection Report

Ed Peace / Peace of Mind Home Inspection
LLC

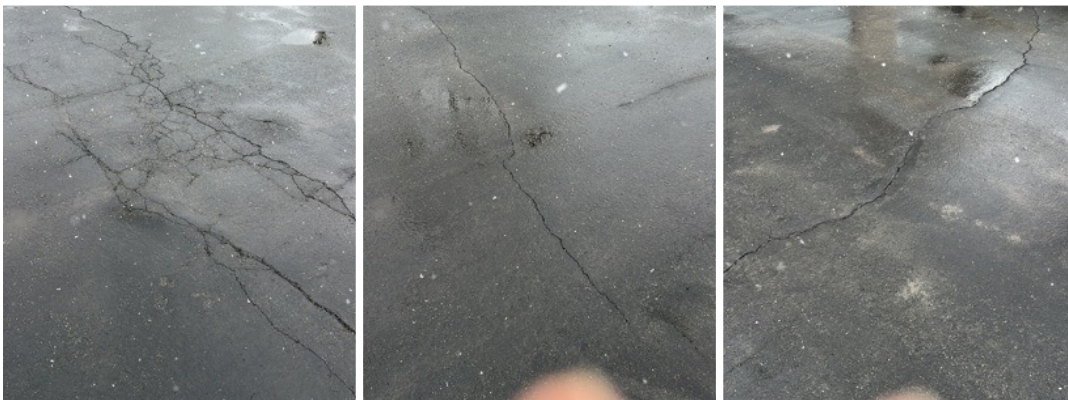
1.1 DRIVEWAY

Heavy crack(s) on surface of the driveway and will cause water intrusion and further deterioration of the asphalt. Recommend a asphalt contractor to assess and repair as necessary.

Recommend sealing crack(s) and resurfacing as needed

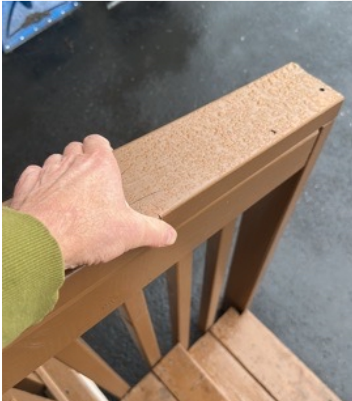
1.5 DECK/BALCONY

Handrails were not graspable

The handrails were made of 2x4 material and were not graspable. This porch and deck are less than 4 steps high so technically handrails are not required but since they are present it would be recommended to change their style so they are more usable.

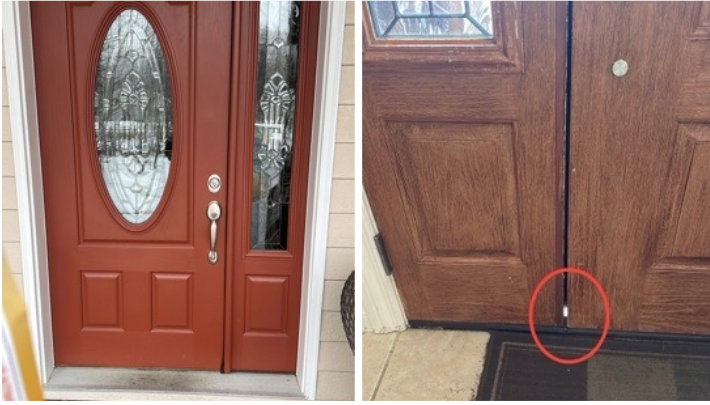
2.4 EXTERIOR DOORS

seal at the bottom of the door is worn and will cause air leakage. recommend replacement.

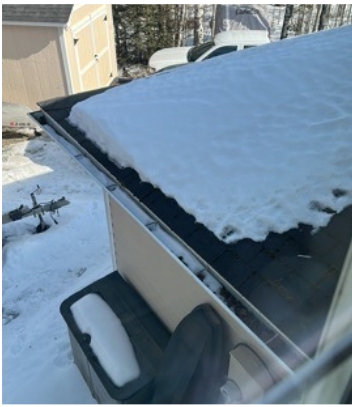
3.2 GUTTERS

The gutter on the west side of the garage roof has leaves and debris and need to be cleaned.

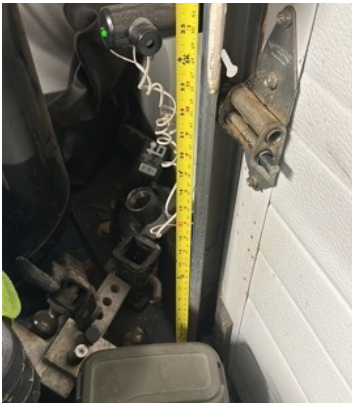
4.8 DOOR OPENER LARGE

Garage Door Safety Sensor Improper Height and Obstruction Potential

Garage door safety sensor is mounted significantly higher than the typical installation height of 6" above the floor. Additionally, stored items are positioned in close proximity, potentially interfering with the sensor's beam path.

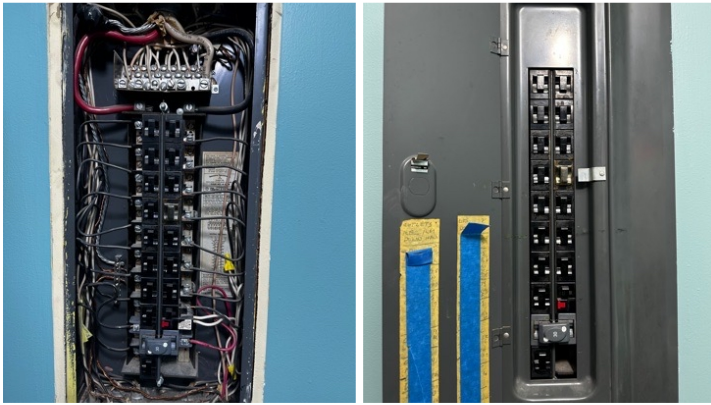
6.2 MAIN PANEL

Obsolete electrical panel

The main electrical panel is an obsolete electrical panel that is no longer supported by the manufacturer and is known to have safety and reliability concerns. These older panels may fail to trip properly, can overheat, and may not meet modern electrical safety standards. Recommend review by a licensed electrical contractor for review and replacement.

IFE Push-matic electrical panel with dead-front panel off

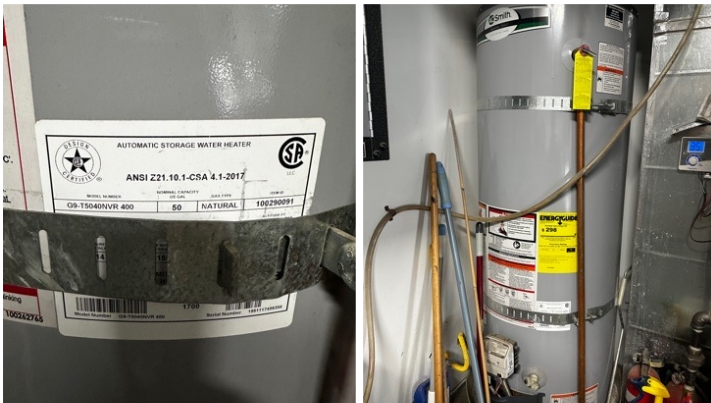
7.6 WATER HEATER

Water heater is nearing the end of its design life. typical water heater lifespan is 7-12 years and this unit is 12 years old.

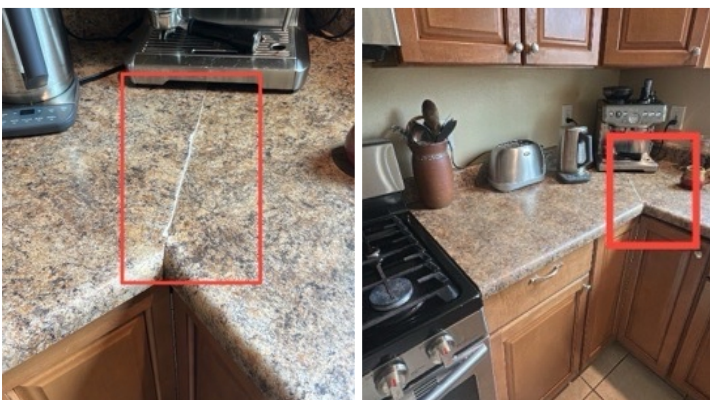
11.2 COUNTERTOPS

Countertop Corner Seam Separation

The laminate countertop shows a visible separation at the corner joint seam, with a gap and deteriorated or missing seam filler or caulking. This can lead to water intrusion into the wood underlayment, causing swelling of the countertop and potentially create an environment for microbial growth.

Location - Kitchen corner adjacent to the stove

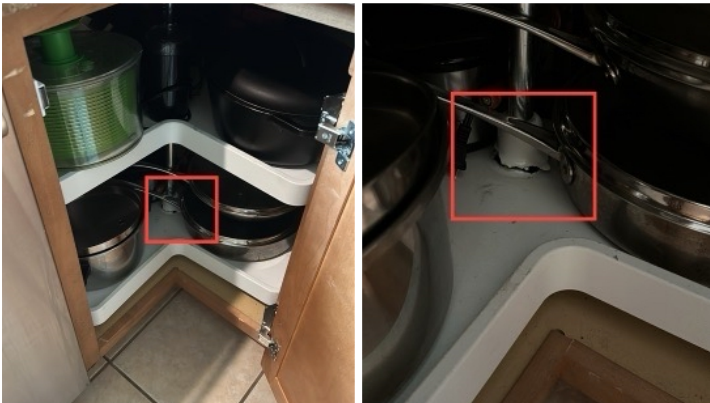
11.3 CABINETS

Corner cabinet lazy susan was broken around the center pole and requires replacement.

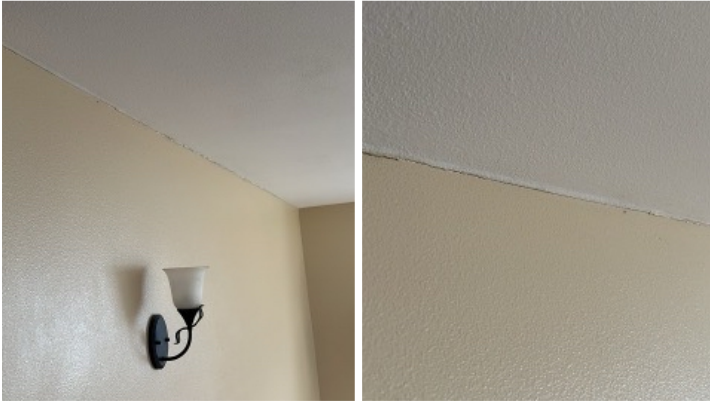
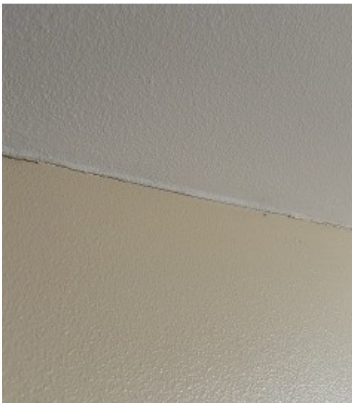
12.2 CEILING

Ceiling-Wall Joint Separation and Cracking

Visible separation and cracking along the ceiling-to-wall joint, with uneven finishing and minor gaps noted at the seam.

Testing with a moisture meter showed no indication of water damage and appears to be cosmetic in nature

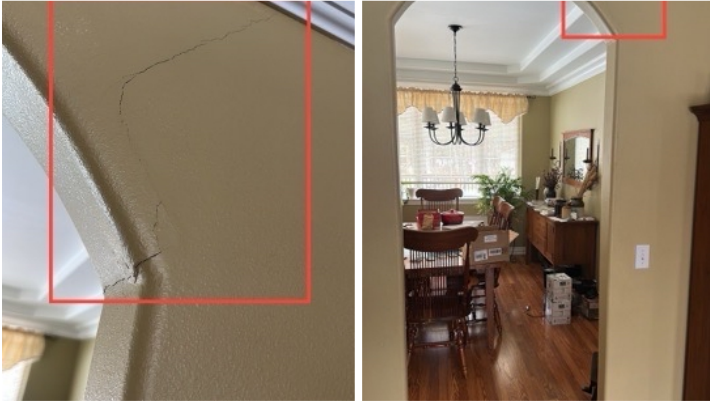
12.3 WALLS

Cracking at Arched Wall Opening Corner in archway from living to dining room

Cracking is visible at the corner of the arched wall opening, extending vertically and along the curve, with minor separation noted at the joint.

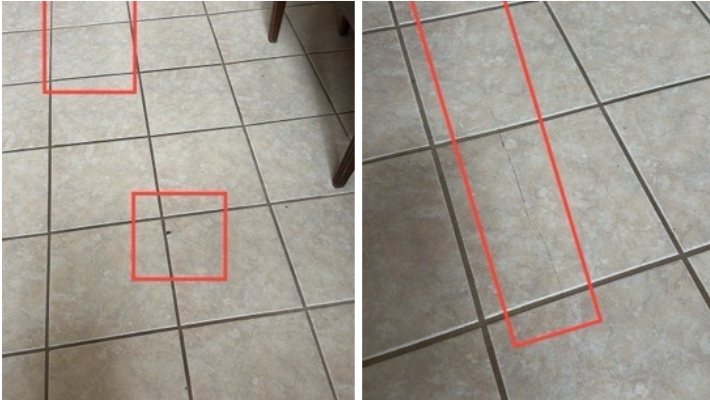
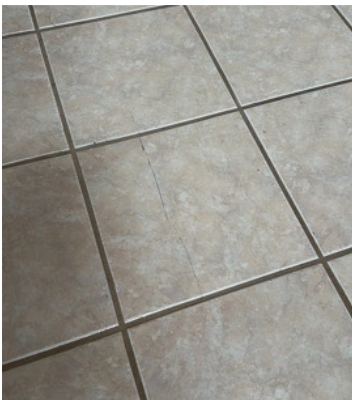
12.4 FLOOR

Cracked Floor Tile Observed

A hairline crack was observed running across two of the floor tiles, indicating localized damage to the tile surface. One additional tile was chipped.

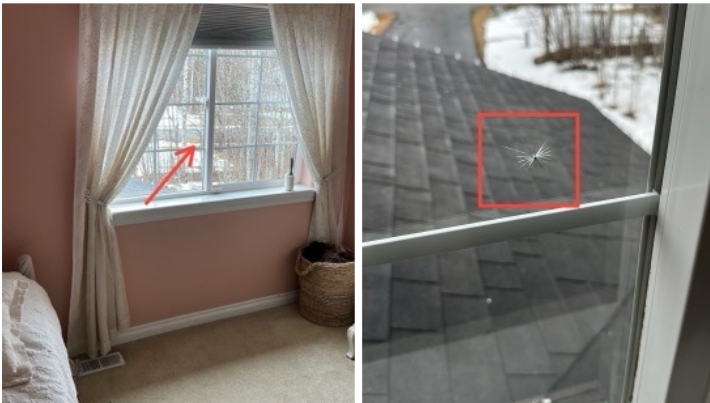
12.6 WINDOWS

Bedroom window has a small star-like impact crack on the inside pane.

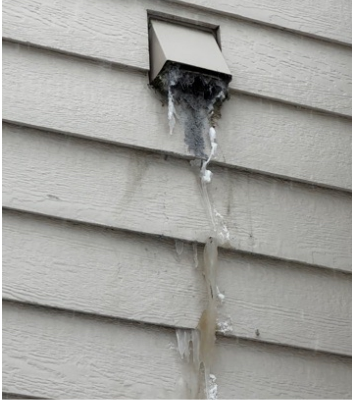
13.2 DRYER VENT

Recommend cleaning dryer vent to ensure proper airflow and to prevent a fire hazard. cleaning the outside vent will allow the damper to close properly.

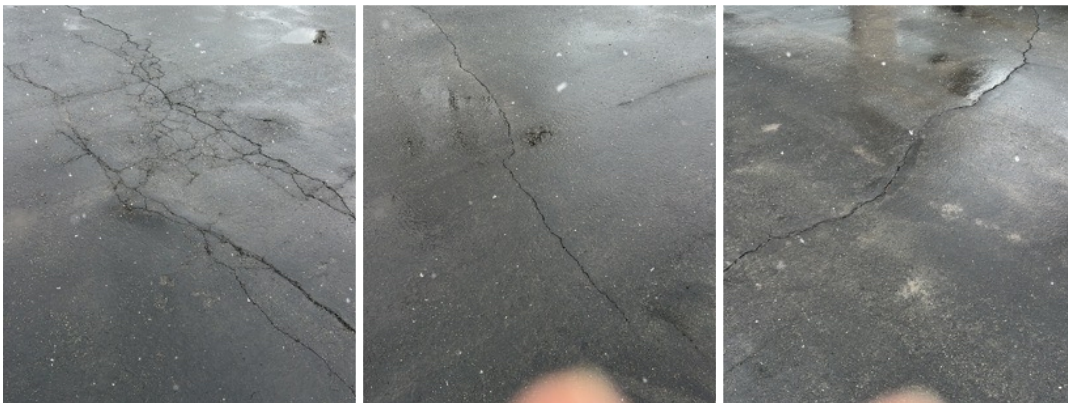
1.1 DRIVEWAY

Heavy crack(s) on surface of the driveway and will cause water intrusion and further deterioration of the asphalt. Recommend a asphalt contractor to assess and repair as necessary.

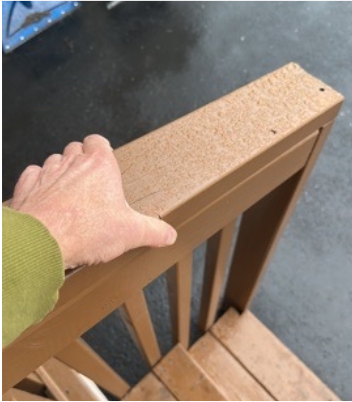
1.5 DECK/BALCONY

Handrails were not graspable

The handrails were made of 2x4 material and were not graspable. This porch and deck are less than 4 steps high so technically handrails are not required but since they are present it would be recommended to change their style so they are more usable.

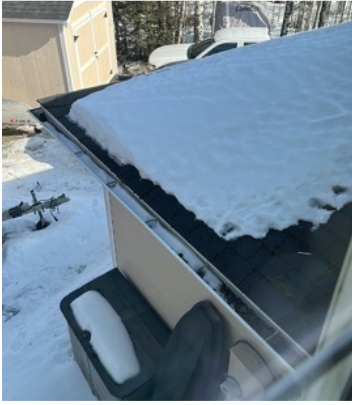
3.2 GUTTERS

The gutter on the west side of the garage roof has leaves and debris and need to be cleaned.

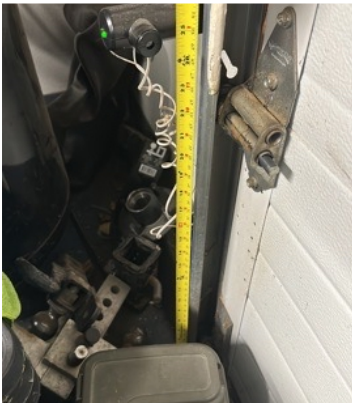
4.8 DOOR OPENER LARGE

Garage Door Safety Sensor Improper Height and Obstruction Potential

Garage door safety sensor is mounted significantly higher than the typical installation height of 6" above the floor. Additionally, stored items are positioned in close proximity, potentially interfering with the sensor's beam path.

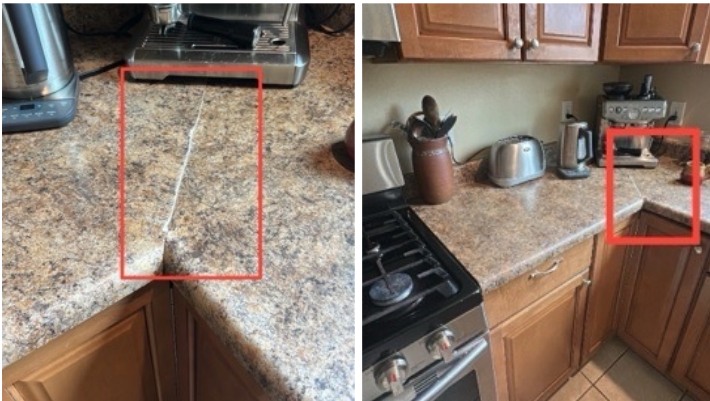
11.2 COUNTERTOPS

Countertop Corner Seam Separation

The laminate countertop shows a visible separation at the corner joint seam, with a gap and deteriorated or missing seam filler or caulking. This can lead to water intrusion into the wood underlayment, causing swelling of the countertop and potentially create an environment for microbial growth.

Location - Kitchen corner adjacent to the stove

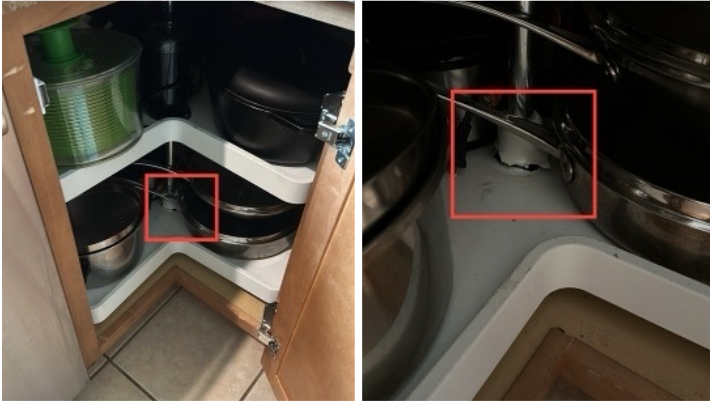
11.3 CABINETS

Corner cabinet lazy susan was broken around the center pole and requires replacement.

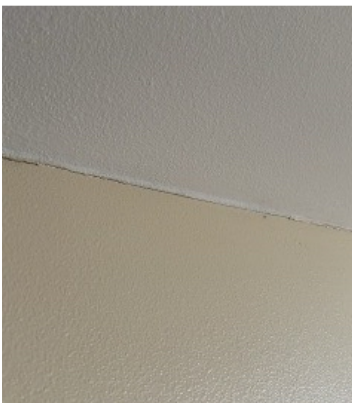
12.2 CEILING

Ceiling-Wall Joint Separation and Cracking

Visible separation and cracking along the ceiling-to-wall joint, with uneven finishing and minor gaps noted at the seam.

Testing with a moisture meter showed no indication of water damage and appears to be cosmetic in nature

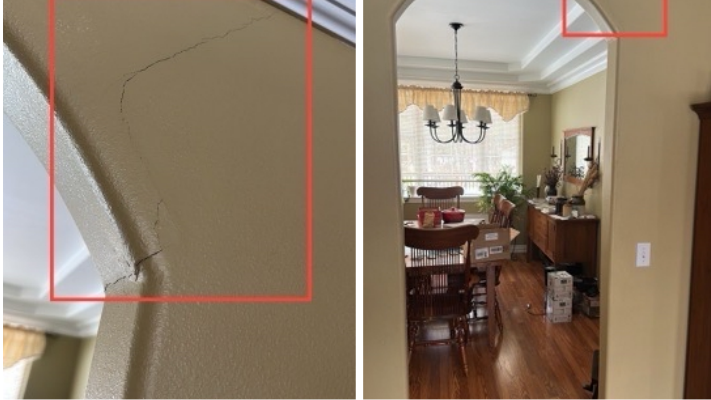
12.3 WALLS

Cracking at Arched Wall Opening Corner in archway from living to dining room

Cracking is visible at the corner of the arched wall opening, extending vertically and along the curve, with minor separation noted at the joint.

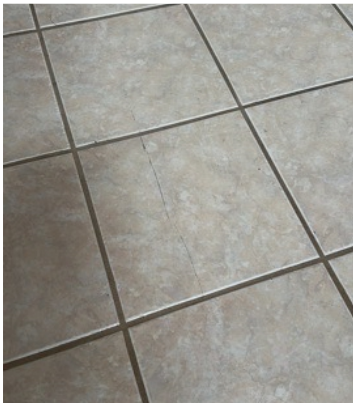
12.4 FLOOR

Cracked Floor Tile Observed

A hairline crack was observed running across two of the floor tiles, indicating localized damage to the tile surface. One additional tile was chipped.

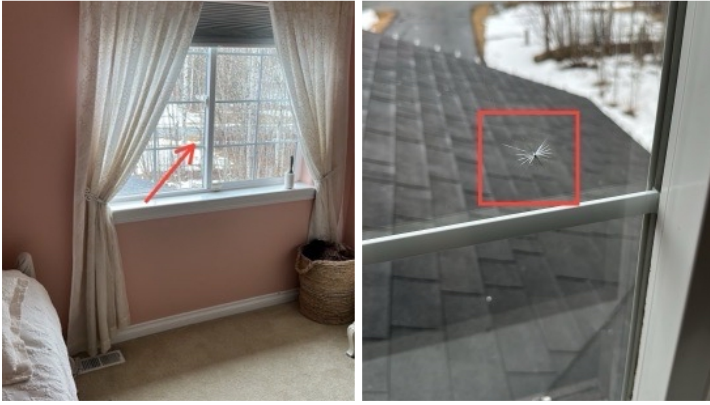
12.6 WINDOWS

Bedroom window has a small star-like impact crack on the inside pane.

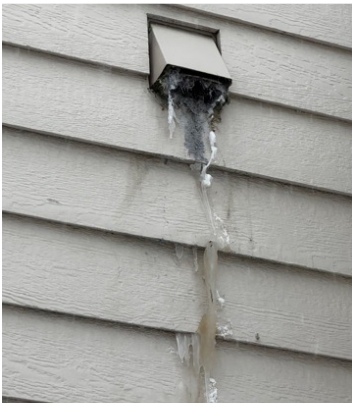
13.2 DRYER VENT

Recommend cleaning dryer vent to ensure proper airflow and to prevent a fire hazard. cleaning the outside vent will allow the damper to close properly.
