Apr 3rd, 2026

3444 N Inspiration loop, Wasilla, AK 99654

# Home Inspection Report

Ed Peace / Peace of Mind Home Inspection  
LLC

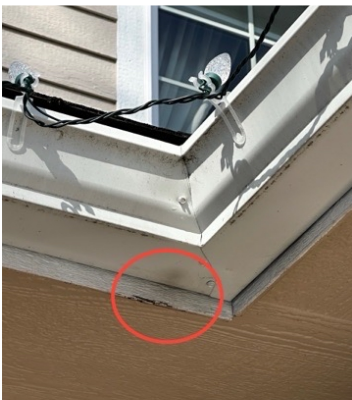
facia board above the porch show sign of water staining in the corner by the gutter. Recommend closer examination by qualified contractor determine if the facia board should be replaced.

Peeling paint indicated water leakage behind the gutter and is causing some deterioration of the fascia board.

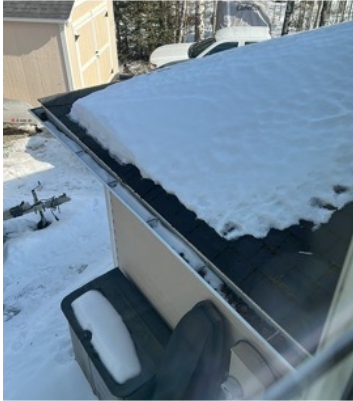
Location - West

Gutters need cleaning

gutter on the back west side of the garage needs to be cleaned due to leaves inside the gutter

Need cleaning

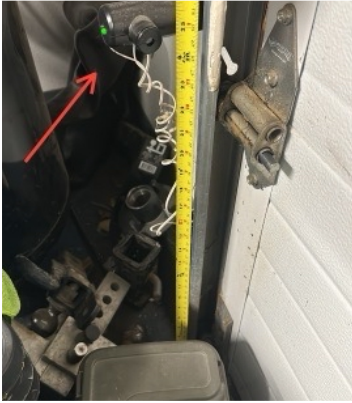
Safety system needs adjustment

remote sensors should be 6" above the ground. these were 24"

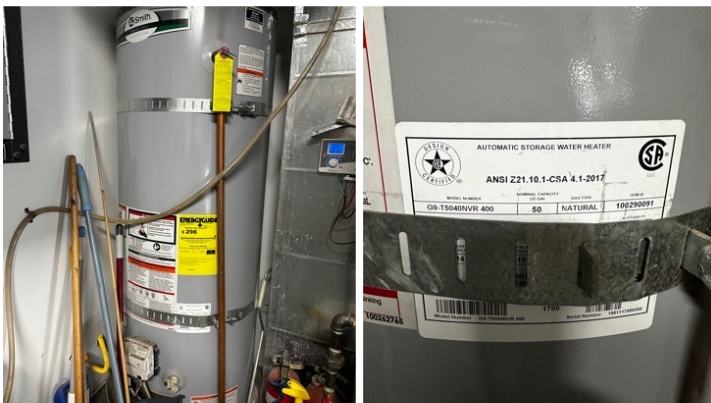
TPR pipe extends to the drain pan but should extend to the floor to ensure proper drainage.

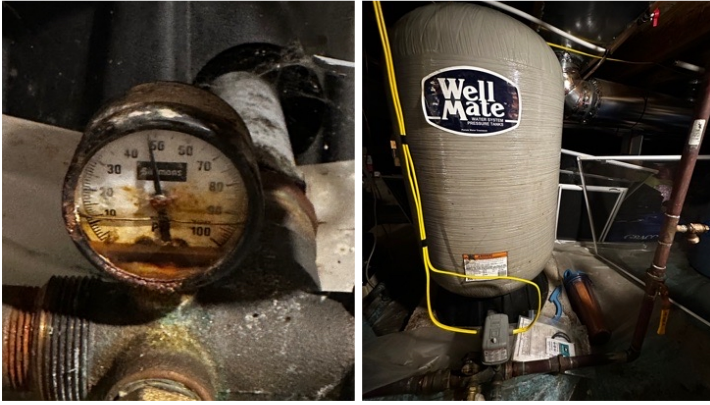
Water pressure was in range between 40-90 psig

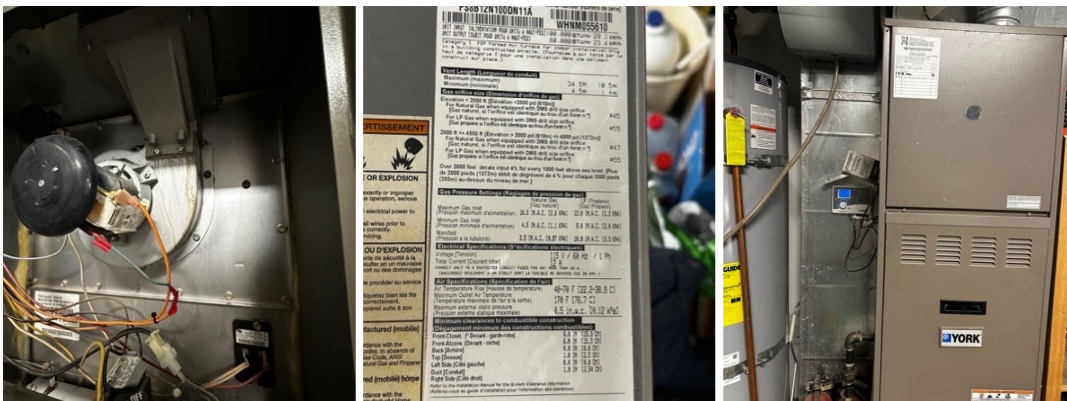
The furnace is a forced air, natural gas fired furnace. There was evidence of routine maintenance, and the induction fan motor was recently replaced. The inspector recommends annual cleaning and inspection by a certified HVAC contractor for optimum performance and safety.

Newly installed induction fan

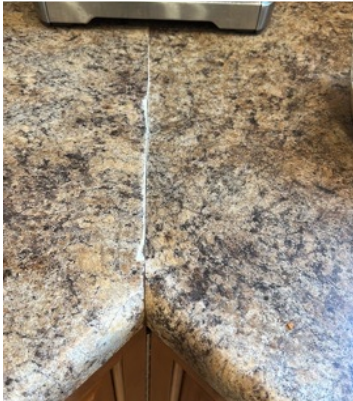
Countertop Seam Separation and Failed Sealant

A visible separation is present at the countertop seam, with deteriorated or missing sealant. This condition can allow moisture intrusion, leading to potential swelling, damage, or microbial growth beneath the surface. It is recommended to clean and properly reseal the seam with an appropriate waterproof sealant to prevent further deterioration.

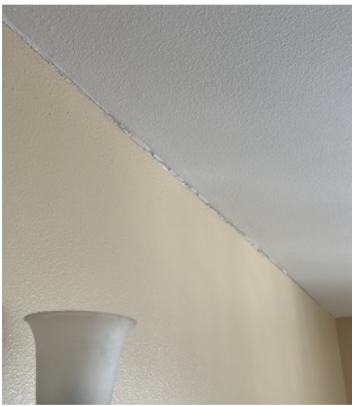
### Ceiling-to-Wall Joint Separation and Cracking

A visible separation is present along the joint where the ceiling meets the wall, with cracking and uneven caulking/tape line noted along the seam. This is cosmetic only but due to its height the inspector would recommend a qualified professional make the repair.

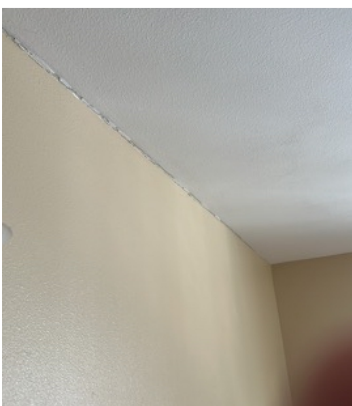
Typical cracking/flaws were observed in ceiling finish

Ceiling above stairs showed a failed mud tape seam

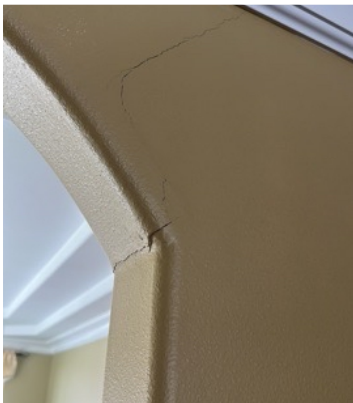
Location - Living room into dining room arch

Cracking at Wall Arch Corner

Cracking was observed at the upper corner of the wall opening/arch, with visible separation along the joint and extending into the adjacent wall surface. This appears to be cosmetic only due to settling.

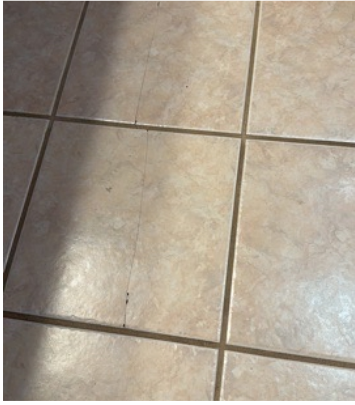
Powder bathroom down-  
stairs

Cracked floor tile in various places  
noticed 6 total floor tiles that were cracked either from impact or settling.

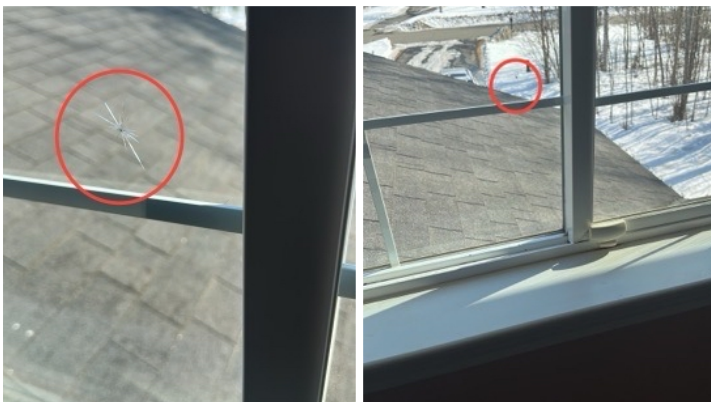
Small impact star crack  
from inside. Does not af-  
fect the exterior pane

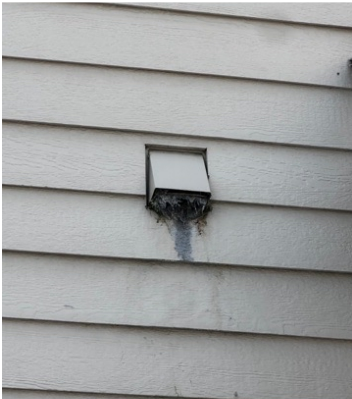
Outside dryer vent has an excessive amount of lint preventing the cover from closing.

Recommend cleaning dryer vent

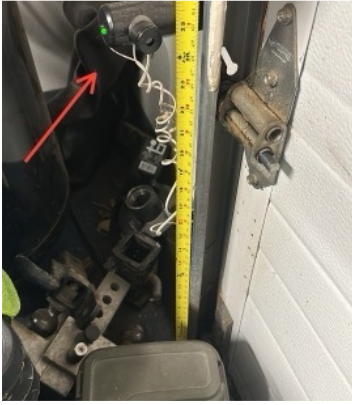
Safety system needs adjustment

remote sensors should be 6" above the ground. these were 24"

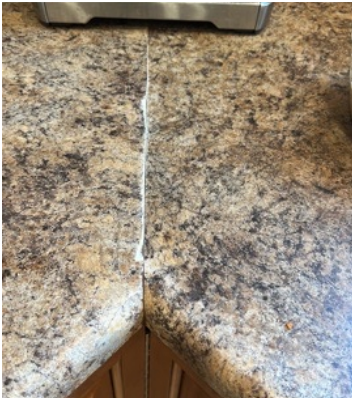
#### Countertop Seam Separation and Failed Sealant

A visible separation is present at the countertop seam, with deteriorated or missing sealant. This condition can allow moisture intrusion, leading to potential swelling, damage, or microbial growth beneath the surface. It is recommended to clean and properly reseal the seam with an appropriate waterproof sealant to prevent further deterioration.
